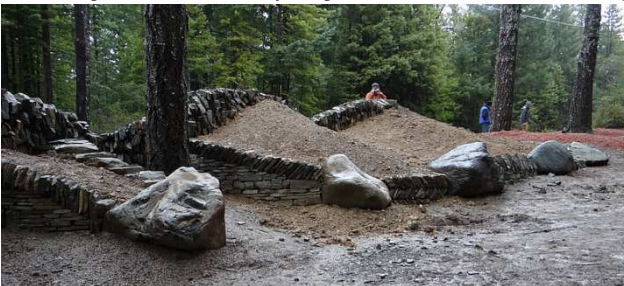
Fig.14. Back of the Wing wall (1)

Once the bridge was completed I did return to help with the finishing of the wing wall. It was built so that the face was good, but with a very rough back which was to have soil piled up against it. There were trees quite close to the wall which would need to be protected from the soil and I was designated the task of building a small wall along the length to protect the trees and further define the extent of the build, plus go over a drain pipe. This, in keeping with much else, I made up as I went along. It too could not be uniform so as it wound around the trees I employed subtle variations on the type of coping, and even the stonework with one herringbone section and corners and curves, plus more of Peter’s surplus boulders.

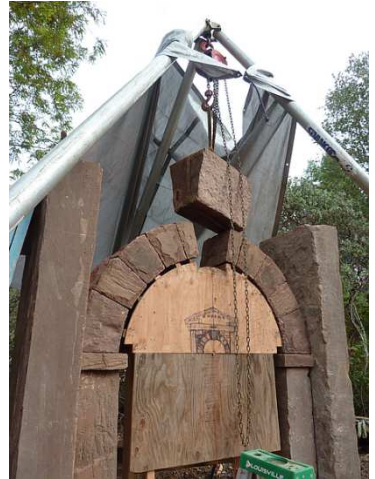
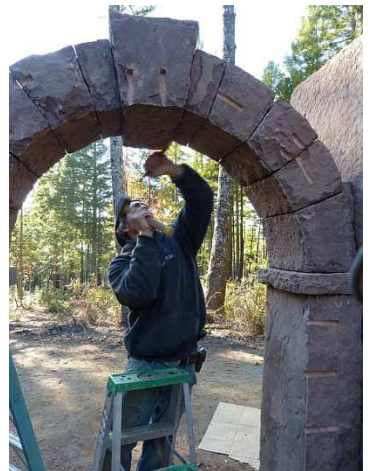
**Figs.16. (above) and 17 (below)
Setting and working
on the keystone
Photos © SeanSmyth**

- 1. Classic Roman Arch with 2 complete complete circles fitting from the top of the intrados to the ground.*
- 2. An odd number of voussoirs.(including keystone)*
- 3 Imposts would have corbels*
- 4 The entire project would be built out of Romero red sandstone.*
- 5 All stones bedding planes would be on the same main axis*
- 6 The voussoirs bedding planes would all point to the center of the circle.*
- 7 The front of the project would be completely natural patina (no tool marks or fresh splits. We did not quite pull this off as the keystone face had to be pitched!*
- 8 The back of the project would show off all of our plug and feather work.*
- 9 Erect the entire structure with aluminium tripod and chain hoist"*

Kyle points out that it is not a true pediment as it has gaps above the extrados, having run out if time and materials to complete it. This has remained as built, making a statement in its own right
